# Manhole Inspection Summary

Manhole # S71M\_\_004MH

Insp Date: **1/29/08 2:11 PM**

**Location** Address: **1207 Bethlehem Ave.**

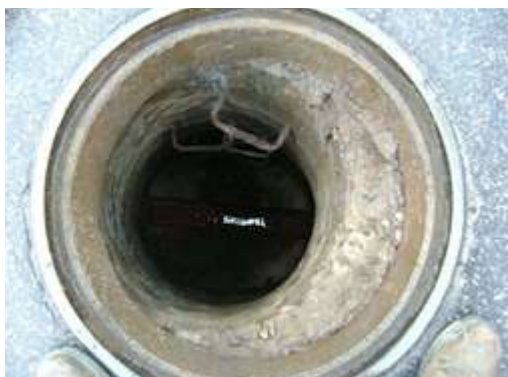
Defect 1

frame offset defect 4 in.

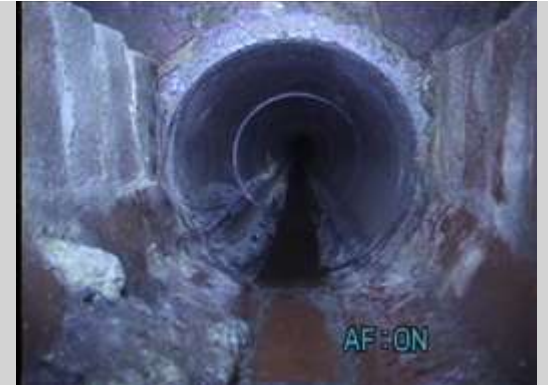
12 O'Clock Outflow

8 in. Circular Gravity Sewer  
Pipe Out @ 12 O'Clock

Pipe Height: **8.4** (in.) Rod and Bar (Angled)  
Pipe Material: **Clay** ☐ Pipe Lined  
Invert Depth: **10.67** (ft.) Flow Characteristics: **None**  
Deposits: ☒ None ☐ Mud ☐ Sludge ☐ Debris ☐ Grease  
Silt Depth: (in.) Deposits Extent:  
Infiltration: **None** Pipe Seal Cond: **Sound**

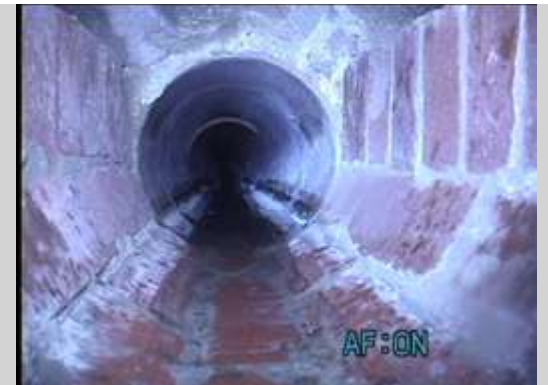
6 O'Clock Inflow

8 in. Circular Gravity Sewer  
Pipe In @ 6 O'Clock

Pipe Height: **8.4** (in.) Rod and Bar (Angled)  
Pipe Material: **Clay** ☐ Pipe Lined  
Invert Depth: **10.67** (ft.) Flow Characteristics: **None**  
Deposits: ☒ None ☐ Mud ☐ Sludge ☐ Debris ☐ Grease  
Silt Depth: (in.) Deposits Extent:  
Infiltration: **None** Pipe Seal Cond: **Sound**
